**Flood Control Project Maintenance
Levee Inspections**
LMA District Cover Sheet
Spring 2017 Levee Inspection Results

American River Flood Control District

Spring 2017 Levee Inspection Results

Waterway			Bank	Unit Miles
Unit No. 01 Arcade Creek			Left	2.08
	Spring (March - May)	Summer (June - August)	(September - November) Fall	Winter (December - February)
Unit Maintenance Rating (Fall Only)				
Date of Inspection	3/15/2017 - 5/3/2017			
DWR Inspector	Maksim Khashchuk			
Accompanied By	Ross Kawamura ARFCD

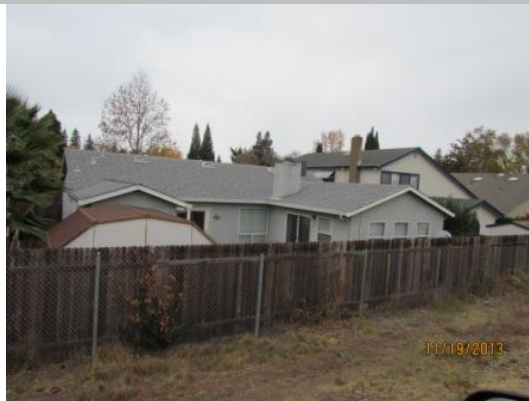
Photo 1 of 1 : SP_2017_NA0001_55_170_20170313_00148.jpg

LM Start	10.73	Rating **	U	Issue No.	170
LM End	10.73	Issue Type +	En	Location *	LS
Category	Earthen Levee			GPS Latitude/Longitude	
				Start	End
Item	Encroachments			38.566981 °	38.566981 °
				-121.352213 °	-121.352213 °
DWR ID	DWR_NA0001_04_f_2012_170				
Comment Code					
FE : Fence					
Inspector Comment					
Wooden privacy fence within 10-ft of levee toe.

View of the fence obstructing visibility and access.

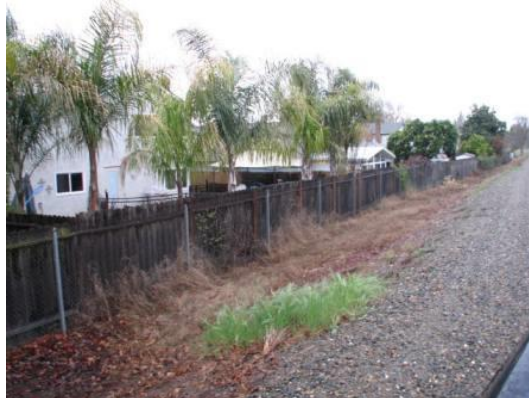
Photo 1 of 1 : SP_2017_NA0001_55_166_20170313_00144.jpg

LM Start	10.75	Rating **	U	Issue No.	166
LM End	10.75	Issue Type +	En	Location *	LS
Category	Earthen Levee			GPS Latitude/Longitude	
				Start	End
Item	Encroachments			38.566705 °	38.566705 °
				-121.352063 °	-121.352063 °
DWR ID	DWR_NA0001_04_s_2012_166				
Comment Code					
FE : Fence					
Inspector Comment					
Wooden privacy fence within 10-ft of levee toe.

03/16/2012 Wood privacy fence completely obstructs access and visibility.

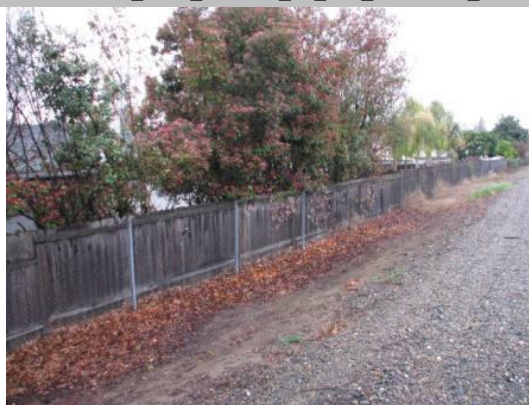
Photo 1 of 1 : SP_2017_NA0001_55_171_20170313_00149.jpg

LM Start	10.76	Rating **	U	Issue No.	171
LM End	10.76	Issue Type +	En	Location *	LS
Category	Earthen Levee			GPS Latitude/Longitude	
				Start	End
Item	Encroachments			38.566499 °	38.566499 °
				-121.351952 °	-121.351952 °
DWR ID	DWR_NA0001_04_s_2012_171				
Comment Code					
FE : Fence					
Inspector Comment					
Wooden privacy fence and tall hedge within 10-ft of levee toe.

03/16/2012 Wood privacy fence completely obstructs access and visibility.

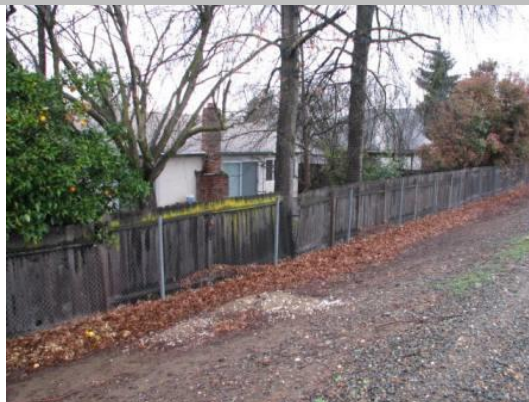
Photo 1 of 1 : SP_2017_NA0001_55_169_20170313_00147.jpg

LM Start	10.77	Rating **	U	Issue No.	169
LM End	10.77	Issue Type +	En	Location *	LS
Category	Earthen Levee			GPS Latitude/Longitude	
				Start	End
Item	Encroachments			38.566399 °	38.566399 °
				-121.351931 °	-121.351931 °
DWR ID	DWR_NA0001_04_s_2012_169				
Comment Code					
FE : Fence					
Inspector Comment					
Wooden privacy fence within 10-ft of levee toe.

03/16/2012 Wood privacy fence completely obstructs access and visibility.

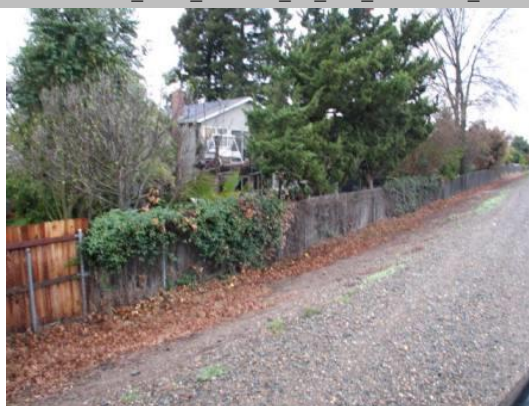
Photo 1 of 1 : SP_2017_NA0001_55_167_20170313_00145.jpg

LM Start	10.78	Rating **	U	Issue No.	167
LM End	10.78	Issue Type +	En	Location *	LS
Category	Earthen Levee			GPS Latitude/Longitude	
				Start	End
Item	Vegetation			38.566233 °	38.566233 °
				-121.351848 °	-121.351848 °
DWR ID	DWR_NA0001_04_s_2012_167				
Comment Code					
V6 : Landscaping					
Inspector Comment					
Wooden privacy fence ivy and vine planted within 10-ft of levee toe.

03/16/2012 Wood privacy fence completely obstructs access and visibility.

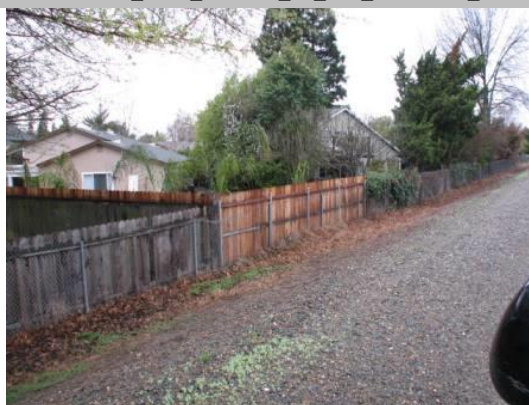
Photo 1 of 1 : SP_2017_NA0001_55_165_20170313_00143.jpg

LM Start	10.80	Rating **	U	Issue No.	165
LM End	10.80	Issue Type +	En	Location *	LS
Category	Earthen Levee			GPS Latitude/Longitude	
				Start	End
Item	Encroachments			38.566044 °	38.566044 °
				-121.351747 °	-121.351747 °
DWR ID	DWR_NA0001_04_s_2012_165				
Comment Code					
FE : Fence					
Inspector Comment					
Wooden privacy fence within 10-ft of levee toe.

03/16/2012 Wood privacy fence completely obstructs access and visibility.

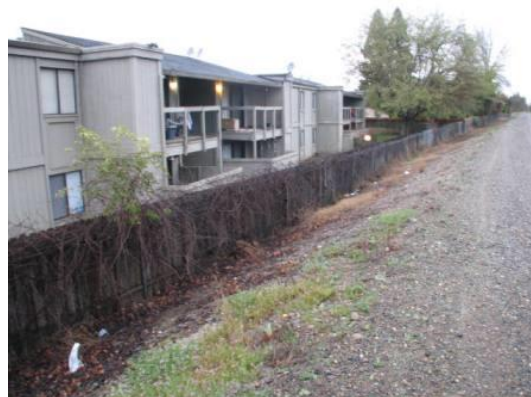
Photo 1 of 1 : SP_2017_NA0001_55_168_20170313_00146.jpg

LM Start	10.81	Rating **	U	Issue No.	168
LM End	10.83	Issue Type +	En	Location *	LS
Category	Earthen Levee			GPS Latitude/Longitude	
				Start	End
Item	Encroachments			38.565917 °	38.565646 °
				-121.351682 °	-121.351532 °
DWR ID	DWR_NA0001_04_s_2012_168				
Comment Code					
FE : Fence					
Inspector Comment					
Wooden privacy fence within 10-ft of levee toe.

03/16/2012 Wood privacy fence completely obstructs access and visibility.

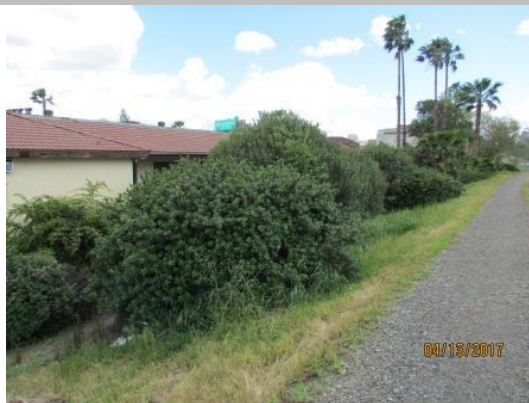
Photo 1 of 1 : SP_2017_NA0001_56_2_20170417_00003.jpg

LM Start	0.10	Rating **	U	Issue No.	2
LM End	0.17	Issue Type +	En	Location *	LS
Category	Earthen Levee			GPS Latitude/Longitude	
				Start	End
Item	Vegetation			38.595044 °	38.594117 °
				-121.506497 °	-121.506377 °
DWR ID	DWR_NA0001_05_s _ 2012_2				
Comment Code					
V6 : Landscaping					
Inspector Comment					
Landscaping behind Best Western. This appears to be permit 8760, but the landscaping is not maintained per title 23 standards.

View of the landscaping on the landside levee slope obstructing visibility and access.

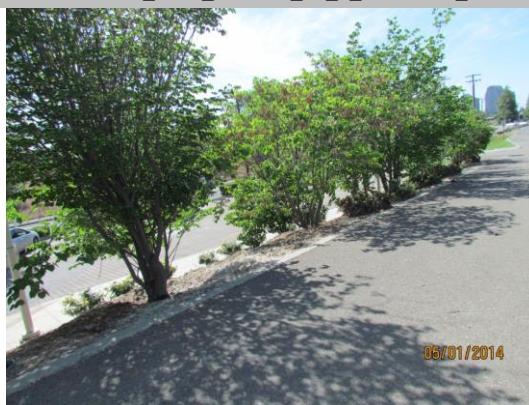
Photo 1 of 1 : SP_2017_NA0001_56_5_20170313_00002.jpg

LM Start	0.27	Rating **	M	Issue No.	5
LM End	0.35	Issue Type +	En	Location *	LS
Category	Earthen Levee			GPS Latitude/Longitude	
				Start	End
Item	Vegetation			38.592630 °	38.591517 °
				-121.505850 °	-121.505447 °
DWR ID	DWR_NA0001_05_s _ 2012_5				
Comment Code					
V6 : Landscaping					
Inspector Comment					
Landscaping at City intake facility.

View of the landscaping on the landside levee slope at the City intake facility.

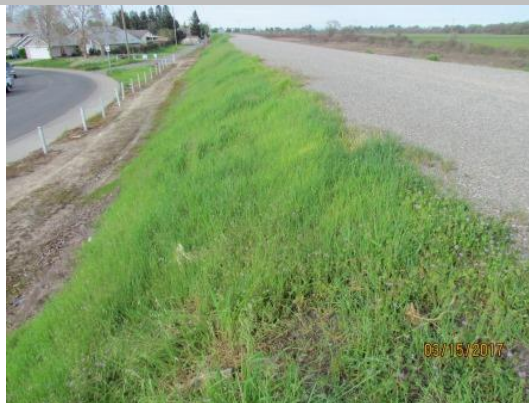
Photo 1 of 1 : SP_2017_NA0001_57_4_20170327_00007.jpg

LM Start	0.09	Rating **	M	Issue No.	4
LM End	0.75	Issue Type +	Ma	Location *	LS
Category	Earthen Levee			GPS Latitude/Longitude	
				Start	End
Item	Vegetation			38.657288 °	38.660498 °
				-121.473096 °	-121.461799 °
DWR ID	DWR_NA0001_06_s_2017_4				
Comment Code					
V1 : Control annual grass and weeds on the levee slopes and easements.					
Inspector Comment

View of the annual vegetation on the levee slope.

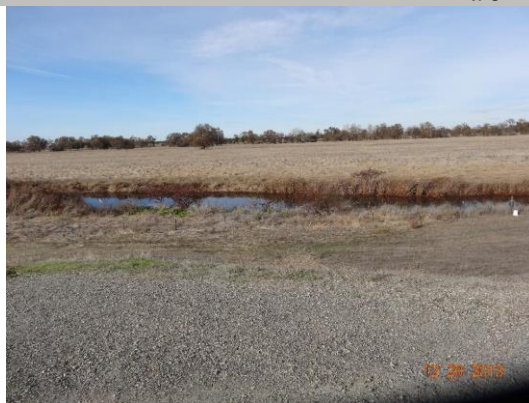
Photo 1 of 3 : UCIP_SP_2017_30706_56559.jpg

LM Start	0.75	Rating **	M	Issue No.	7
LM End	0.75	Issue Type +	En	Location *	LS
Category	Supplemental			GPS Latitude/Longitude	
				Start	End
Item	DWR UCIP Field Study			38.660518 °	38.660518 °
				-121.461826 °	-121.461826 °
DWR ID					
Comment Code					
Inspector Comment					
FS_ID:30706 DS_ID:24812 EP_NO: N/A Repair Type: Non-Urgent Crossing Status: Indicator Found UCIP Comments: Unable to confirm if line goes through levee or along landward slope. No permit found. FIELD_STRUCT_DESC: Storm drain manhole located on landside (LS). FS Date: 12/20/2013

View of waterward side.

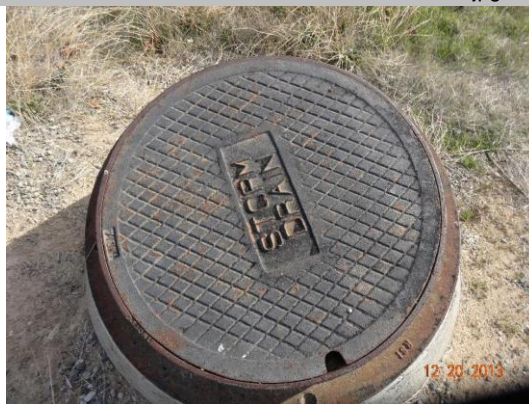
Photo 3 of 3 : UCIP_SP_2017_30706_56557.jpg

Manhole located on landward side identified as storm drain. Unable to determine if drain crosses levee.

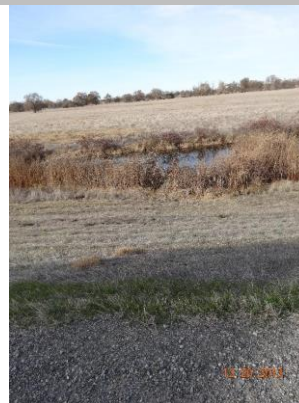
Photo 1 of 3 : UCIP_SP_2017_29223_54002.jpg

Comment Code					
Inspector Comment					
FS_ID:29223 DS_ID:24354 EP_NO: N/A Repair Type: Non-Urgent Crossing Status: Indicator Found UCIP Comments: Unable to find CM riser and flap gate on waterward end--need to contact owner to determine status of crossing. Manhole found on landward side however unable to determine if manhole is part of this crossing. FIELD_STRUCT_DESC: 24-inch pipe through the levee, 12.5 feet below the crown. Two corrugated metal (CM) cutoff walls around pipe. Slide gate in CM riser and flap gate at waterside (WS) end. Concrete headwalls on both ends. (USACE-1959). This entry matches the Drainage or Irrigation Structure referenced in O&M manual (Station 440+50). FS Date: 12/20/2013

View of waterward side--no evidence of crossing.

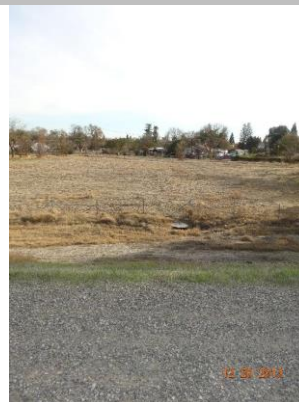
Photo 2 of 3 : UCIP_SP_2017_29223_54001.jpg

View of landward side--manhole on landward toe.

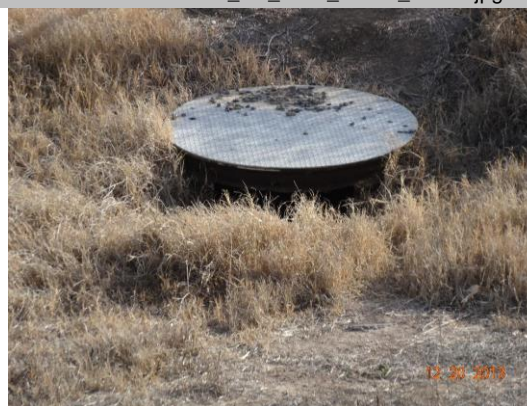
Photo 3 of 3 : UCIP_SP_2017_29223_54000.jpg

Comment Code						
Inspector Comment						
FS_ID:29223						
DS_ID:24354						
EP_NO: N/A						
Repair Type: Non-Urgent						
Crossing Status: Indicator Found						
UCIP Comments: Unable to find CM riser and flap gate on waterward end--need to contact owner to determine status of crossing. Manhole found on landward side however unable to determine if manhole is part of this crossing.						
FIELD_STRUCT_DESC: 24-inch pipe through the levee, 12.5 feet below the crown. Two corrugated metal (CM) cutoff walls around pipe. Slide gate in CM riser and flap gate at waterside (WS) end. Concrete headwalls on both ends. (USACE-1959). This entry matches the Drainage or Irrigation Structure referenced in O&M manual (Station 440+50).						
FS Date: 12/20/2013

Manhole visible on landward toe.

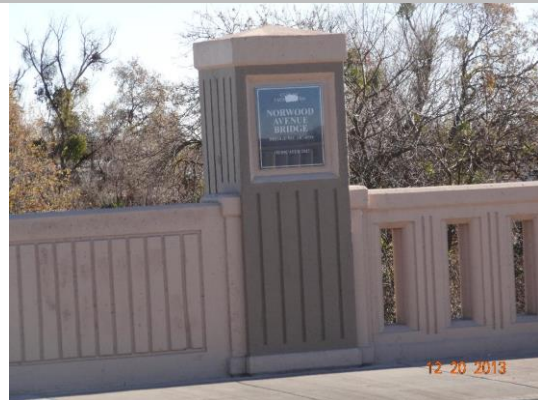
Photo 1 of 3 : UCIP_SP_2017_49931_54061.jpg

Comment Code					
Inspector Comment					
FS_ID:49931 DS_ID:24363 EP_NO: 3417 Repair Type: Urgent Crossing Status: Found UCIP Comments: 8/11/2016 Markers still missing. LMA representatives, Tim Kerr and Richard Marck, provided permit for PG&E line to be raised to 200-year water surface elevation. Pipe will be raised on both the right and left banks. Depth below the crown will need to be updated once construction is completed. (DWR UCIP - omagana)12/19/2013 Missing gas line markers -- need to contact owner to determine status. (DWR UCIP - omagana) FIELD_STRUCT_DESC: 4-inch steel gas line through the levee, 2 feet below the crown. Corrugated metal (CM) cutoff wall around pipe at the center of the levee. 4-inch gate valve will be installed on the LS approximately 355 feet from levee crown (near Fairbanks Avenue and Norwood Avenue). (4-inch pipe installed under Permit No. 3417, 1961 - Pacific Gas and Electric Company [PG&E]; 4-inch pipe removed and replaced under Permit 18641, 2011 - PG&E; 4-inch pipe through levee (both right and left bank) raised above the 200-year water surface elevation under Permit No. 18641-1, 2016 - PG&E) [Additional Reference(s): DWR Levee Log, 2002] FS Date: 8/11/2016

Norwood Avenue Bridge

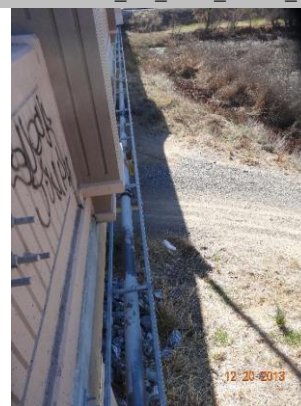
Photo 2 of 3 : UCIP_SP_2017_49931_54062.jpg

Comment Code						
Inspector Comment						
FS_ID:49931 DS_ID:24363 EP_NO: 3417 Repair Type: Urgent Crossing Status: Found UCIP Comments: 8/11/2016 Markers still missing. LMA representatives, Tim Kerr and Richard Marck, provided permit for PG&E line to be raised to 200-year water surface elevation. Pipe will be raised on both the right and left banks. Depth below the crown will need to be updated once construction is completed. (DWR UCIP - omagana)12/19/2013 Missing gas line markers -- need to contact owner to determine status. (DWR UCIP - omagana) FIELD_STRUCT_DESC: 4-inch steel gas line through the levee, 2 feet below the crown. Corrugated metal (CM) cutoff wall around pipe at the center of the levee. 4-inch gate valve will be installed on the LS approximately 355 feet from levee crown (near Fairbanks Avenue and Norwood Avenue). (4-inch pipe installed under Permit No. 3417, 1961 - Pacific Gas and Electric Company [PG&E]; 4-inch pipe removed and replaced under Permit 18641, 2011 - PG&E; 4-inch pipe through levee (both right and left bank) raised above the 200-year water surface elevation under Permit No. 18641-1, 2016 - PG&E) [Additional Reference(s): DWR Levee Log, 2002] FS Date: 8/11/2016

View of pipe attached to bridge.

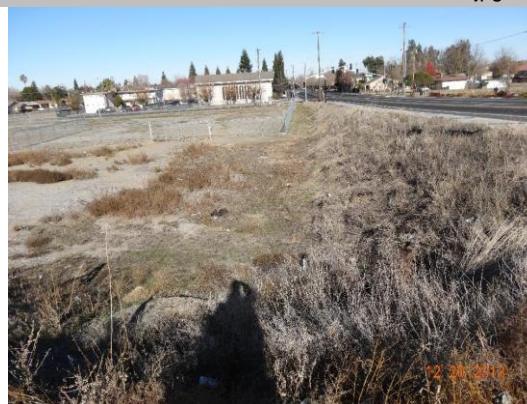
Photo 3 of 3 : UCIP_SP_2017_49931_54060.jpg

View of LS.

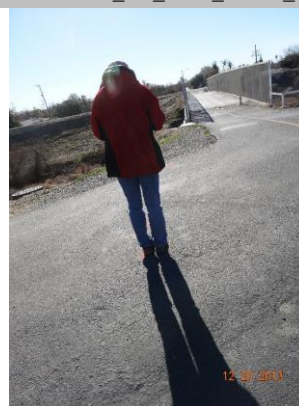
Photo 2 of 3 : UCIP_SP_2017_40803_48511.jpg

LM Start	1.24	Rating **	M	Issue No.	46 (cont)	
LM End	1.24	Issue Type +	En	Location *	LS	
Category	Supplemental			GPS Latitude/Longitude		
				Start	End	
Item	DWR UCIP Field Study			38.625785 °	38.625785 °	
				-121.447464 °	-121.447464 °	
DWR ID						
Comment Code						
Inspector Comment						
FS_ID:40803						
DS_ID:24447						
EP_NO: 16466						
Repair Type: Non-Urgent						
Crossing Status: Found						
UCIP Comments: Need to contact owner to determine if crossings are at this location are associated with Permit number 16466--unable to confirm crossings.						
FIELD_STRUCT_DESC: Two 6-inch and one 2-inch concrete encased steel utility conduits through the levee, all approximately 2.0 feet below the crown. Manhole on the levee crown. (Permit No. 16466-1995)						
FS Date: 12/20/2013

View of levee crown and estimate where crossings cross levee.

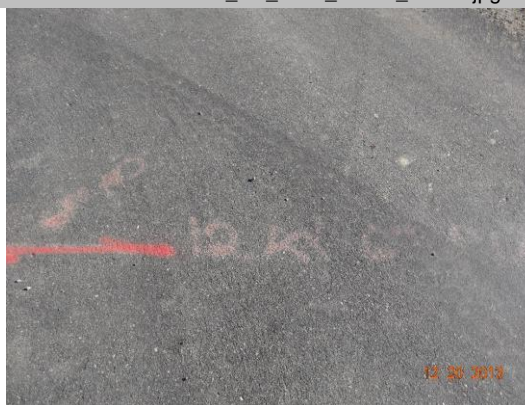
Photo 3 of 3 : UCIP_SP_2017_40803_48510.jpg

Underground Service Alert (USA) faint utility markers visible on levee crown.

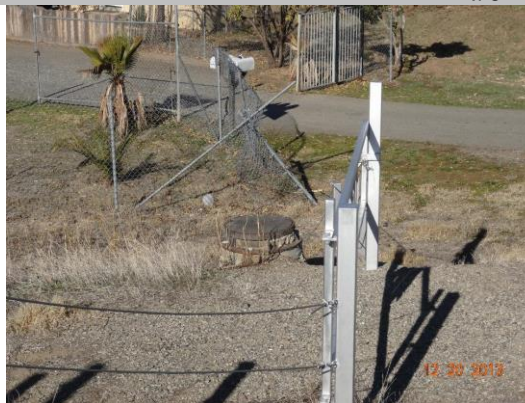
Photo 1 of 1 : UCIP_SP_2017_29275_54199.jpg

LM Start	1.31	Rating **	M	Issue No.	47
LM End	1.31	Issue Type +	En	Location *	LS
Category	Supplemental			GPS Latitude/Longitude	
				Start	End
Item	DWR UCIP Field Study			38.626198 °	38.626198 °
				-121.446321 °	-121.446321 °
DWR ID					
Comment Code					
Inspector Comment					
FS_ID:29275 DS_ID:24553 EP_NO: N/A Repair Type: Non-Urgent Crossing Status: Found UCIP Comments: Only manhole present--need to coordinate with owner to determine if crossing is still presnt and whether manhole corresponds to this crossing. FIELD_STRUCT_DESC: 8-inch (not 10-inch as indicated in desk study) sewer pipe through the levee, 7.5 feet below the crown. Floodgates within the levee across the channel, installed under Permit No. 14480 (1986). FS Date: 12/20/2013

Manhole visible on landward side.

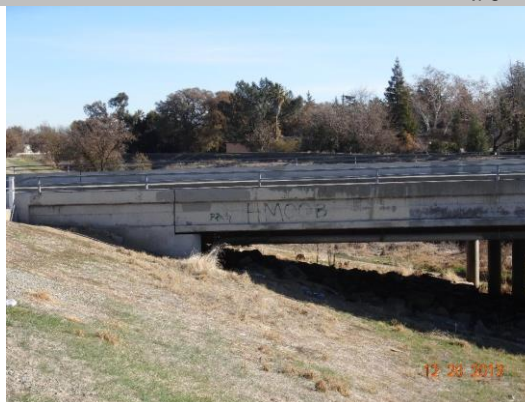
Photo 1 of 2 : UCIP_SP_2017_49933_75853.jpg

Comment Code					
Inspector Comment					
FS_ID:49933 DS_ID:24443 EP_NO: 15152 Repair Type: Urgent Crossing Status: Indicator Found UCIP Comments: 8/11/2016 Markers still missing. Will need to update depth below crown once construction is completed. (DWR UCIP - omagana)12/20/2013 Unable to confirm if crossing is the same one authorized through permit. (DWR UCIP - omagana) FIELD_STRUCT_DESC: 4-inch steel gas main through the levee, 2.5 feet below the crown. Vent is located on the waterside (WS) shoulder. (4-inch line installed under Permit No. 15152, 1989 - Pacific Gas and Electric Company [PG&E]; 4-inch will be raised above the 200-year water surface elevation within the levee crown under Permit No. 15152-1, 2016 - PG&E) FS Date: 8/11/2016

View of WS.

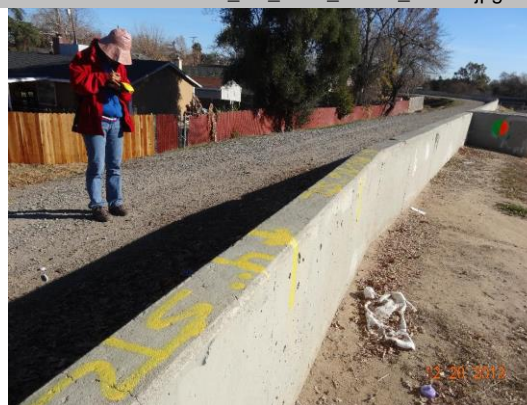
Photo 2 of 3 : UCIP_SP_2017_46795_57525.jpg

LM Start	1.60	Rating **	M	Issue No.	49 (cont)
LM End	1.60	Issue Type +	En	Location *	LS

Underground service alert (USA) markings visible on floodwall.

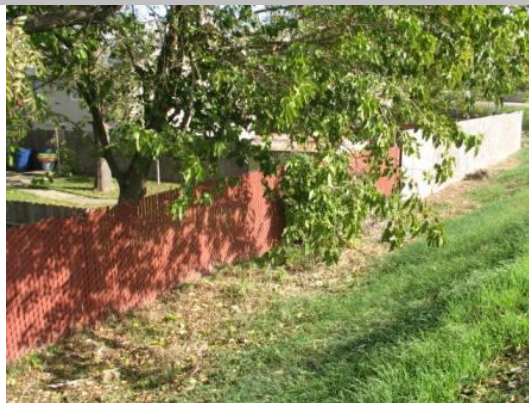
Photo 1 of 1 : SP_2017_NA0001_58_27_20170313_00022.jpg

LM Start	1.63	Rating **	U	Issue No.	27
LM End	1.63	Issue Type +	En	Location *	LS
Category	Earthen Levee			GPS Latitude/Longitude	
				Start	End
Item	Encroachments			38.627681 °	38.627681 °
				-121.441021 °	-121.441021 °
DWR ID	DWR_NA0001_07_s _ 2012_27				
Comment Code					
FE : Fence					
Inspector Comment					
Privacy fence and overgrown trees are within 10-ft of the levee toe.

11/17/2011 Privacy fence is constructed at the toe.

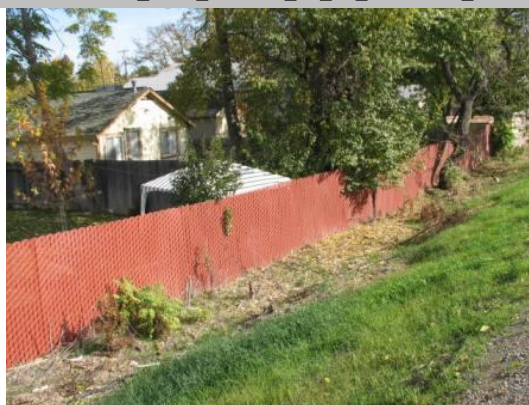
Photo 1 of 1 : SP_2017_NA0001_58_28_20170313_00023.jpg

LM Start	1.63	Rating **	M	Issue No.	28
LM End	1.63	Issue Type +	En	Location *	LS
Category	Earthen Levee			GPS Latitude/Longitude	
				Start	End
Item	Encroachments			38.627668 °	38.627668 °
				-121.441018 °	-121.441018 °
DWR ID	DWR_NA0001_07_s _ 2012_28				
Comment Code					
FE : Fence					
Inspector Comment					
Privacy fence is within 10-ft of the levee toe.

11/17/2011 Privacy fence is constructed at the toe.

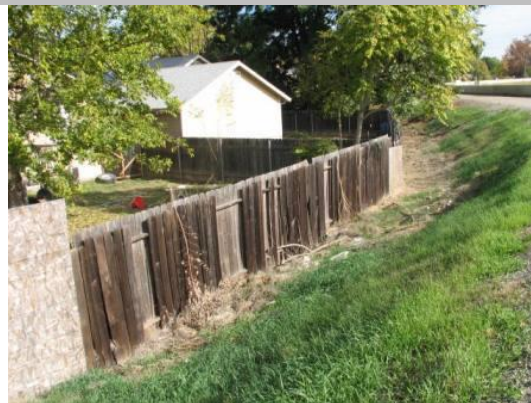
Photo 1 of 1 : SP_2017_NA0001_58_25_20170313_00020.jpg

LM Start	1.65	Rating **	U	Issue No.	25
LM End	1.65	Issue Type +	En	Location *	LS
Category	Earthen Levee			GPS Latitude/Longitude	
				Start	End
Item	Encroachments			38.627677 °	38.627677 °
				-121.440629 °	-121.440629 °
DWR ID	DWR_NA0001_07_s_2012_25				
Comment Code					
FE : Fence					
Inspector Comment					
Wooden privacy fence is within 10-ft of the levee toe.

11/17/2011 Wooden privacy fence is constructed at the toe.

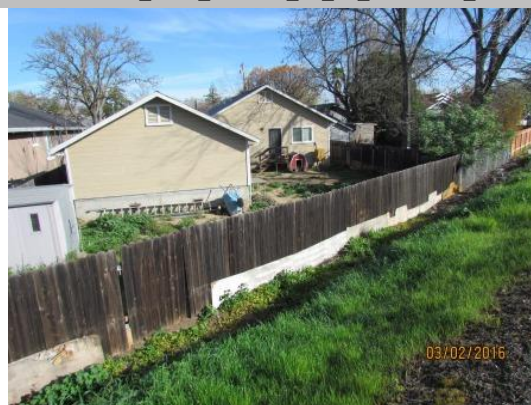
Photo 1 of 1 : SP_2017_NA0001_58_40_20170313_00029.jpg

LM Start	1.66	Rating **	U	Issue No.	40
LM End	1.66	Issue Type +	En	Location *	LS
Category	Earthen Levee			GPS Latitude/Longitude	
				Start	End
Item	Encroachments			38.627727 °	38.627727 °
				-121.440442 °	-121.440442 °
DWR ID	DWR_NA0001_07_s_2016_40				
Comment Code					
FE : Fence					
Inspector Comment

View of the fence at the landside levee toe.

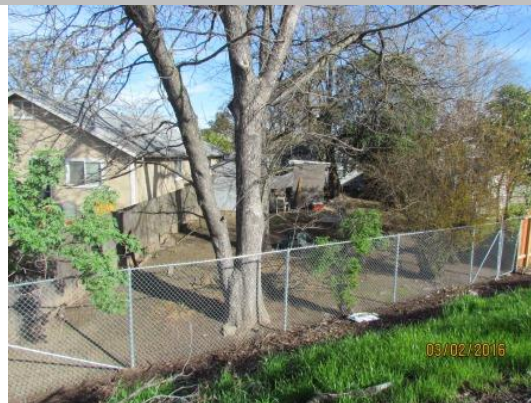
Photo 1 of 1 : SP_2017_NA0001_58_41_20170313_00030.jpg

LM Start	1.67	Rating **	M	Issue No.	41
LM End	1.67	Issue Type +	En	Location *	LS
Category	Earthen Levee			GPS Latitude/Longitude	
				Start	End
Item	Encroachments			38.627803 °	38.627803 °
				-121.440270 °	-121.440270 °
DWR ID	DWR_NA0001_07_s_2016_41				
Comment Code					
FE : Fence					
Inspector Comment

View of the fence at the landside levee toe.

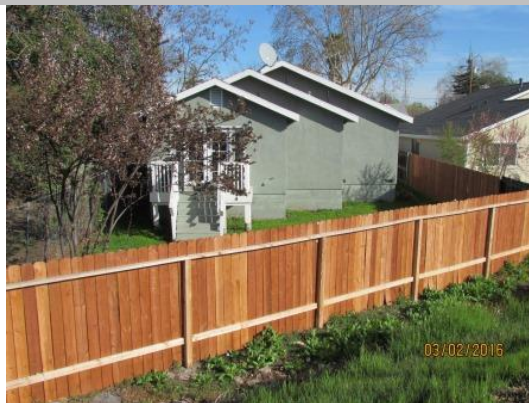
Photo 1 of 1 : SP_2017_NA0001_58_44_20170313_00032.jpg

LM Start	1.68	Rating **	U	Issue No.	44
LM End	1.68	Issue Type +	En	Location *	LS
Category	Earthen Levee			GPS Latitude/Longitude	
				Start	End
Item	Encroachments			38.627874 °	38.627874 °
				-121.440134 °	-121.440134 °
DWR ID	DWR_NA0001_07_s_2016_44				
Comment Code					
FE : Fence					
Inspector Comment

View of the fence at the landside levee toe.

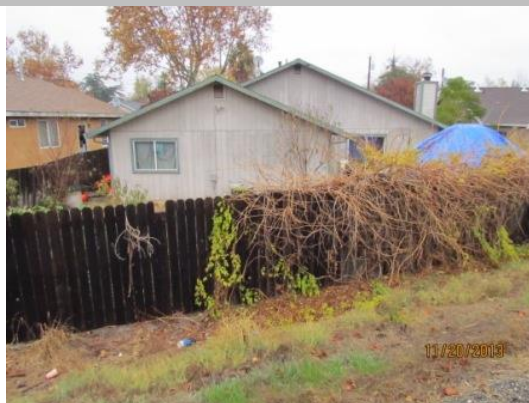
Photo 1 of 1 : SP_2017_NA0001_58_6_20170313_00004.jpg

LM Start	1.69	Rating **	U	Issue No.	6
LM End	1.69	Issue Type +	En	Location *	LS
Category	Earthen Levee			GPS Latitude/Longitude	
				Start	End
Item	Encroachments			38.627948 °	38.627948 °
				-121.439958 °	-121.439958 °
DWR ID	DWR_NA0001_07_s_2012_6				
Comment Code					
FE : Fence					
Inspector Comment					
Wooden privacy fence with vines are within 10-ft of the levee toe.

View of the wooden fence at the landside levee toe.

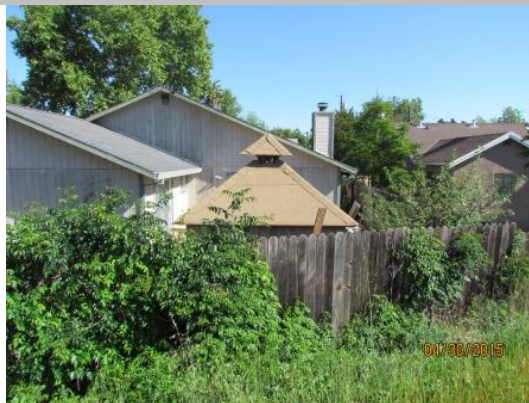
Photo 1 of 1 : SP_2017_NA0001_58_1_20170313_00001.jpg

LM Start	1.69	Rating **	U	Issue No.	1
LM End	1.69	Issue Type +	En	Location *	LS
Category	Earthen Levee			GPS Latitude/Longitude	
				Start	End
Item	Encroachments			38.627956 °	38.627956 °
				-121.439962 °	-121.439962 °
DWR ID	DWR_NA0001_07_s_2012_1				
Comment Code					
BU : Building					
Inspector Comment					
Construction of new structure is witin 15' of levee.

View of the shed at the landside levee toe.

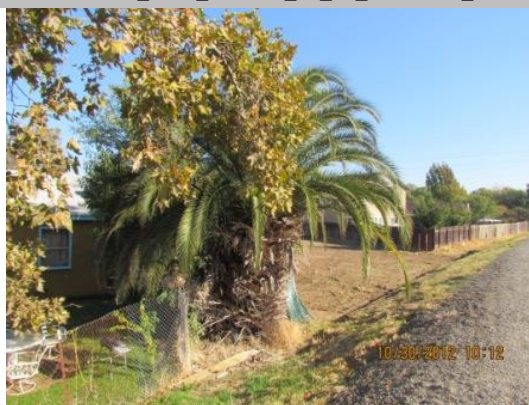
Photo 1 of 1 : SP_2017_NA0001_58_24_20170313_00019.jpg

LM Start	1.72	Rating **	M	Issue No.	24
LM End	1.72	Issue Type +	En	Location *	LS
Category	Earthen Levee			GPS Latitude/Longitude	
				Start	End
Item	Vegetation			38.628086 °	38.628086 °
				-121.439544 °	-121.439544 °
DWR ID	DWR_NA0001_07_s_2012_24				
Comment Code					
V6 : Landscaping					
Inspector Comment					
Palm tree was trimmed up.

View of palm tree within 10-ft of the levee toe trimmed up from previous inspection.

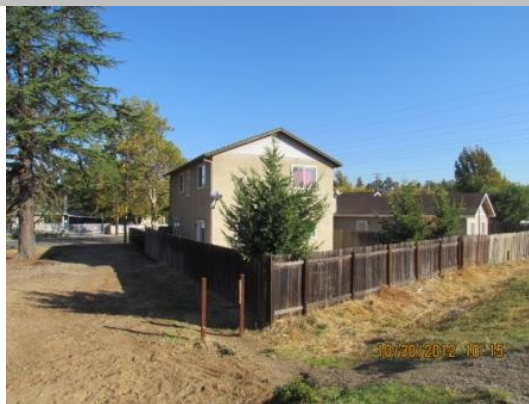
Photo 1 of 1 : SP_2017_NA0001_58_23_20170313_00018.jpg

LM Start	1.74	Rating **	U	Issue No.	23	
LM End	1.74	Issue Type +	En	Location *	LS	
Category	Earthen Levee			GPS Latitude/Longitude		
				Start		End
Item	Encroachments			38.628221 °		38.628221 °
				-121.439138 °		-121.439138 °
DWR ID	DWR_NA0001_07_s_2012_23					
Comment Code						
FE : Fence						
Inspector Comment						
Wooden fence and cedar trees are within 10-ft of levee toe.

View of wooden privacy fence constructed at the toe.

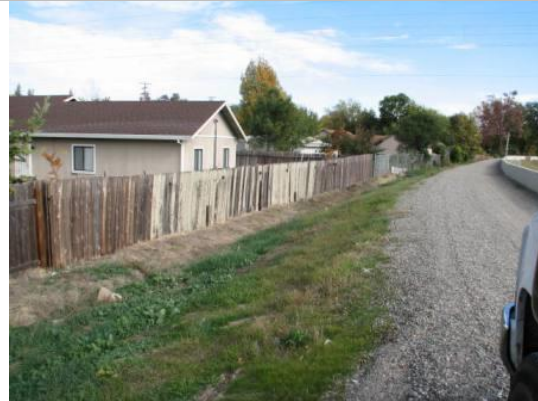
Photo 1 of 1 : SP_2017_NA0001_58_9_20170313_00007.jpg

LM Start	1.75	Rating **	U	Issue No.	9
LM End	1.75	Issue Type +	En	Location *	LS
Category	Earthen Levee			GPS Latitude/Longitude	
				Start	End
Item	Encroachments			38.628197 °	38.628197 °
				-121.438863 °	-121.438863 °
DWR ID	DWR_NA0001_07_s_2012_9				
Comment Code					
FE : Fence					
Inspector Comment					
Wooden privacy fence is within 10-ft of the levee toe.

11/17/2011 Wooden privacy fence is constructed at the toe.

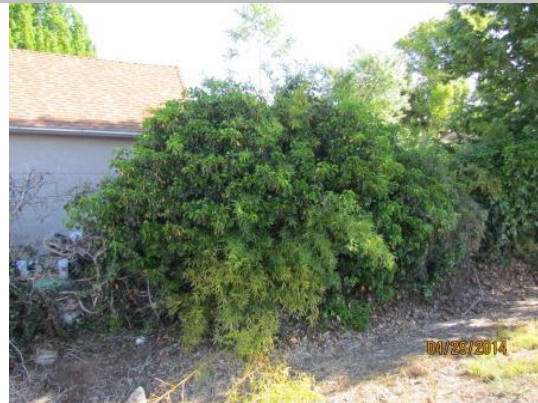
Photo 1 of 1 : SP_2017_NA0001_58_10_20170313_00008.jpg

LM Start	1.79	Rating **	U	Issue No.	10
LM End	1.79	Issue Type +	En	Location *	LS
Category	Earthen Levee			GPS Latitude/Longitude	
				Start	End
Item	Vegetation			38.628273 °	38.628273 °
				-121.438255 °	-121.438255 °
DWR ID	DWR_NA0001_07_s_2012_10				
Comment Code					
V6 : Landscaping					
Inspector Comment					
Ivy and other landscape plantings have grown up chain link fence on the levee toe. Building is within 10-ft of the levee toe. Prunings are on the levee slope.

Landscaping has grown over the fence and obstructs visibility and access.

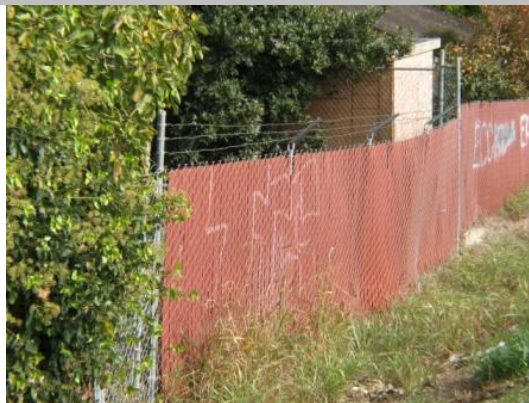
Photo 1 of 1 : SP_2017_NA0001_58_12_20170313_00010.jpg

LM Start	1.81	Rating **	U	Issue No.	12
LM End	1.81	Issue Type +	En	Location *	LS
Category	Earthen Levee			GPS Latitude/Longitude	
				Start	End
Item	Encroachments			38.628307 °	38.628307 °
				-121.437842 °	-121.437842 °
DWR ID	DWR_NA0001_07_s _ 2012_12				
Comment Code					
FE : Fence					
Inspector Comment					
Chain link privacy fence with barbed wire is within 10-ft of levee toe.

11/17/2011 Barbed wire topped privacy fence is located at the toe.

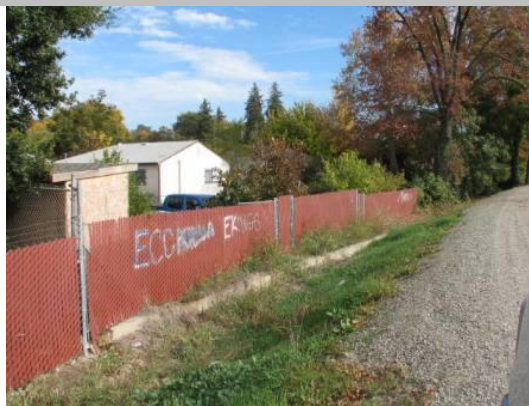
Photo 1 of 1 : SP_2017_NA0001_58_13_20170313_00011.jpg

LM Start	1.82	Rating **	U	Issue No.	13
LM End	1.82	Issue Type +	En	Location *	LS
Category	Earthen Levee			GPS Latitude/Longitude	
				Start	End
Item	Encroachments			38.628303 °	38.628303 °
				-121.437693 °	-121.437693 °
DWR ID	DWR_NA0001_07_s _ 2012_13				
Comment Code					
FE : Fence					
Inspector Comment					
Chain link privacy fence is within 10-ft of levee toe.

11/17/2011 Privacy fence is located at the toe.

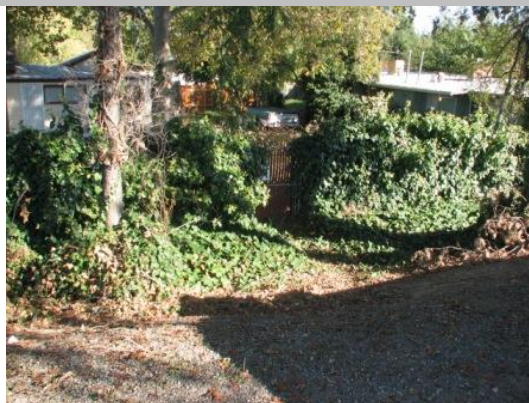
Photo 2 of 2 : SP_2017_NA0001_58_15_20170313_00014.jpg

Fall 2009 photo of dense ivy and fence obstruct visibility and access.

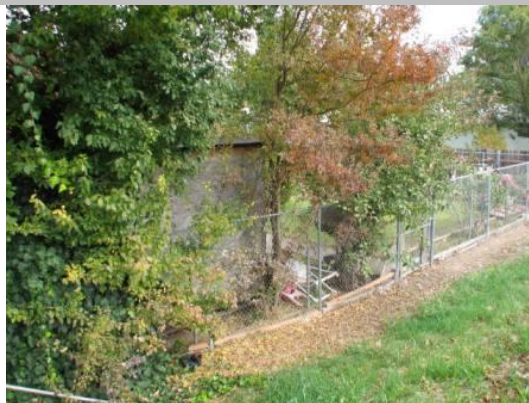
Photo 1 of 1 : SP_2017_NA0001_58_22_20170313_00017.jpg

LM Start	1.87	Rating **	U	Issue No.	22
LM End	1.87	Issue Type +	En	Location *	LS
Category	Earthen Levee			GPS Latitude/Longitude	
				Start	End
Item	Encroachments			38.628318 °	38.628318 °
				-121.436794 °	-121.436794 °
DWR ID	DWR_NA0001_07_s _ 2012_22				
Comment Code					
BU : Building					
Inspector Comment					
Wooden shed and landscaping along chain link fence within 10-ft of levee toe.

11/17/2011 Building is too close to the levee toe and obstructs visibility and access.

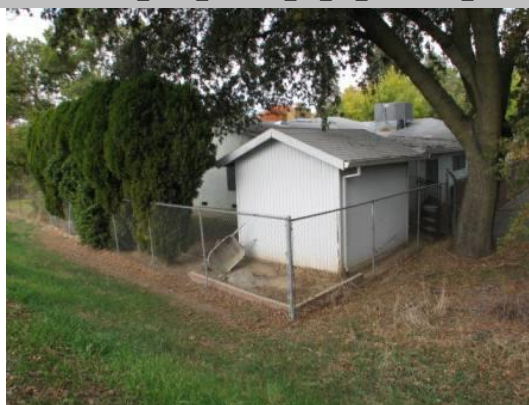
Photo 1 of 1 : SP_2017_NA0001_58_21_20170313_00016.jpg

LM Start	1.89	Rating **	U	Issue No.	21
LM End	1.89	Issue Type +	En	Location *	LS
Category	Earthen Levee			GPS Latitude/Longitude	
				Start	End
Item	Vegetation			38.628280 °	38.628280 °
				-121.436365 °	-121.436365 °
DWR ID	DWR_NA0001_07_s _ 2012_21				
Comment Code					
V6 : Landscaping					
Inspector Comment					
Wooden side building and juniper trees along chain link fence are within 10-ft of landside toe.

11/17/2011 Building and landscaping are too close to the levee toe.

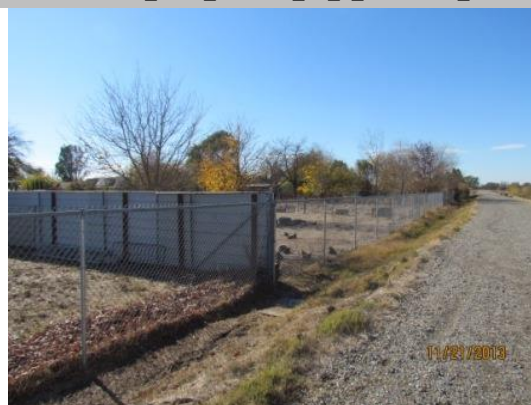
Photo 1 of 1 : SP_2017_NA0001_59_4_20170313_00003.jpg

LM Start	0.30	Rating **	M	Issue No.	4
LM End	0.49	Issue Type +	En	Location *	LS
Category	Earthen Levee			GPS Latitude/Longitude	
				Start	End
Item	Encroachments			38.668191 °	38.668118 °
				-121.442059 °	-121.438659 °
DWR ID	DWR_NA0001_08_s_2012_4				
Comment Code					
FE : Fence					
Inspector Comment					
Chain link fence near levee toe limits access.

View of the chainlink fence at landside levee toe facing downstream.

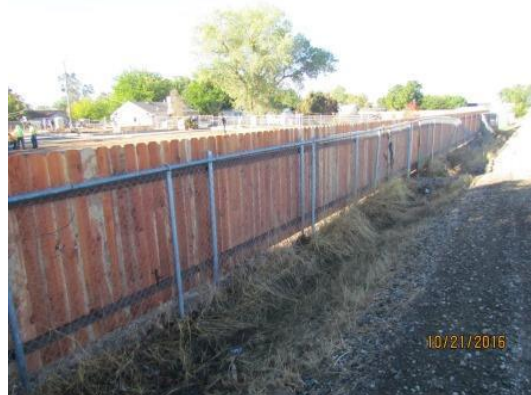
Photo 1 of 1 : SP_2017_NA0001_59_22_20170313_00009.jpg

LM Start	0.37	Rating **	U	Issue No.	22
LM End	0.40	Issue Type +	En	Location *	LS
Category	Earthen Levee			GPS Latitude/Longitude	
				Start	End
Item	Encroachments			38.668123 °	38.668118 °
				-121.440709 °	-121.440268 °
DWR ID	DWR_NA0001_08_s _ 2014_22				
Comment Code					
FE : Fence					
Inspector Comment					
New fence appears to be constructed at the property line. Fence limits visibility of the landside.

View of the fence at the landside levee toe.

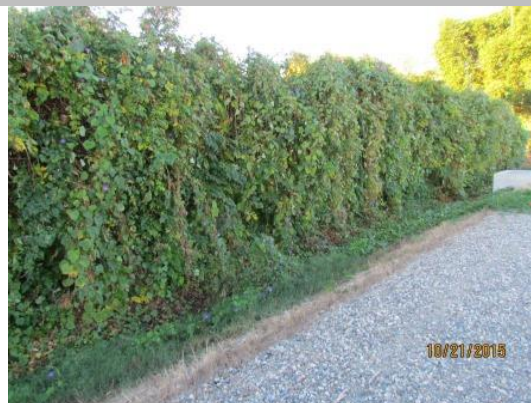
Photo 1 of 1 : SP_2017_NA0001_59_6_20170313_00004.jpg

LM Start	0.40	Rating **	U	Issue No.	6
LM End	0.43	Issue Type +	En	Location *	LS
Category	Earthen Levee			GPS Latitude/Longitude	
				Start	End
Item	Vegetation			38.668147 °	38.668141 °
				-121.440248 °	-121.439755 °
DWR ID	DWR_NA0001_08_s _ 2012_6				
Comment Code					
V6 : Landscaping					
Inspector Comment					
Vines on fence limit visibility.

View of the vines on fence obstructing visibility of landside toe.

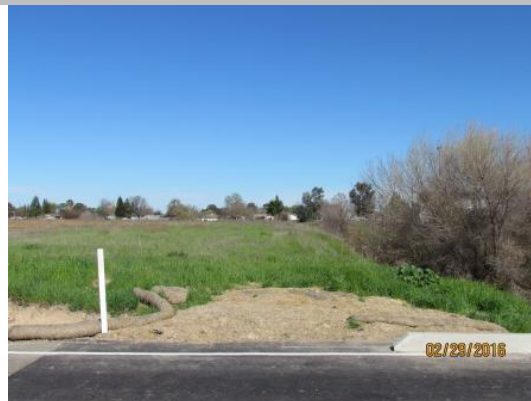
Photo 1 of 1 : SP_2017_NA0001_59_1_20170313_00001.jpg

LM Start	0.51	Rating **	U	Issue No.	1
LM End	1.03	Issue Type +	En	Location *	WS
Category	Earthen Levee			GPS Latitude/Longitude	
				Start	End
Item	Encroachments			38.668132 °	38.665528 °
				-121.438229 °	-121.431688 °
DWR ID	DWR_NA0001_08_s _ 2012_1				
Comment Code					
MA : Material					
Inspector Comment					
This portion of the levee is inaccessible for maintenance.

View from downstream end of inaccessible portion of Magpie Creek.
Channel Maintenance only in this section

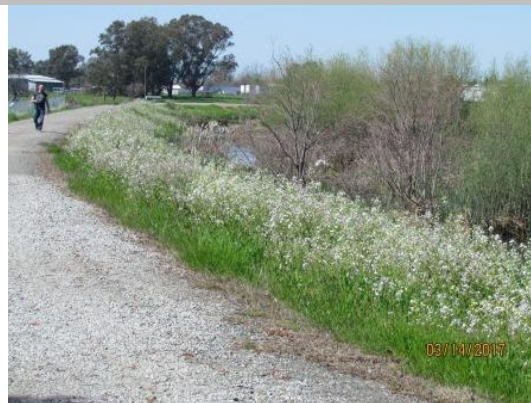
Photo 1 of 1 : SP_2017_NA0001_59_11_20170327_00015.jpg

LM Start	1.06	Rating **	M	Issue No.	11
LM End	1.42	Issue Type +	Ma	Location *	WS
Category	Earthen Levee			GPS Latitude/Longitude	
				Start	End
Item	Vegetation			38.665095 °	38.660805 °
				-121.431683 °	-121.429575 °
DWR ID	DWR_NA0001_08_s_2017_11				
Comment Code					
V1 : Control annual grass and weeds on the levee slopes and easements.					
Inspector Comment

View of the annual vegetation on the waterside levee slope.

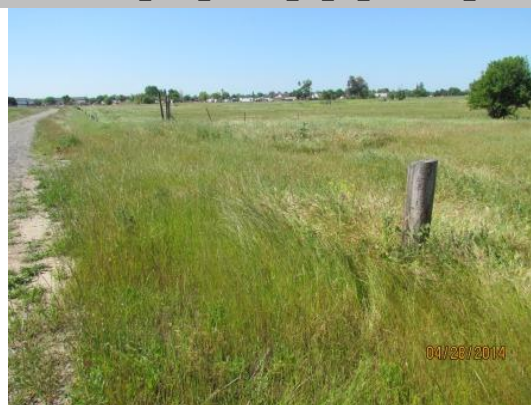
Photo 1 of 1 : SP_2017_NA0001_59_20_20170313_00008.jpg

LM Start	1.22	Rating **	M	Issue No.	20
LM End	1.22	Issue Type +	En	Location *	LS
Category	Earthen Levee			GPS Latitude/Longitude	
				Start	End
Item	Encroachments			38.662816 °	38.662816 °
				-121.431678 °	-121.431678 °
DWR ID	DWR_NA0001_08_s_2014_20				
Comment Code					
PO : Pole					
Inspector Comment

View of the pole on landside levee toe.

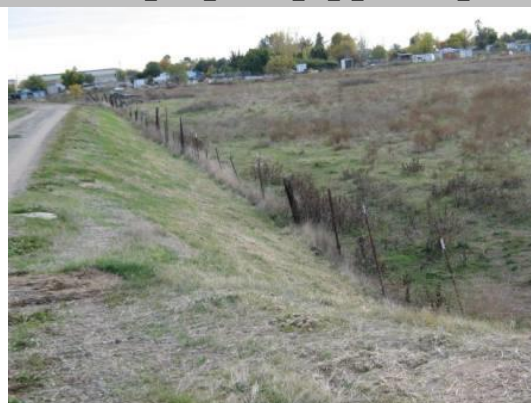
Photo 1 of 1 : SP_2017_NA0001_59_2_20170313_00002.jpg

LM Start	1.22	Rating **	M	Issue No.	2
LM End	1.31	Issue Type +	En	Location *	LS
Category	Earthen Levee			GPS Latitude/Longitude	
				Start	End
Item	Encroachments			38.662715 °	38.661584 °
				-121.431666 °	-121.431402 °
DWR ID	DWR_NA0001_08_s_2012_2				
Comment Code					
FE : Fence					
Inspector Comment					
Barbed wire fence runs along the levee toe.

11/17/2011 Barbed wire fence at levee toe.

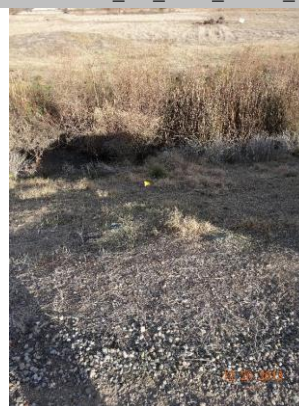
Photo 1 of 2 : UCIP_SP_2017_30689_56509.jpg

LM Start	1.28	Rating **	M	Issue No.	23
LM End	1.28	Issue Type +	En	Location *	LS
Category	Supplemental			GPS Latitude/Longitude	
				Start	End
Item	DWR UCIP Field Study			38.661843 °	38.661843 °
				-121.431675 °	-121.431675 °
DWR ID					
Comment Code					
Inspector Comment					
FS_ID:30689 DS_ID:24815 EP_NO: N/A Repair Type: Non-Urgent Crossing Status: Indicator Found UCIP Comments: unable to confirm if conduit or gas line cross levee or flag identifying problem areas. Need additional information. FIELD_STRUCT_DESC: Underground service alert (USA) markers found on waterside (WS) and landside (LS) during field inspection. FS Date: 12/20/2013

View of waterward side.

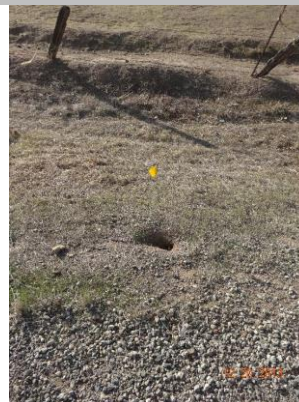
Photo 2 of 2 : UCIP_SP_2017_30689_56508.jpg

LM Start	1.28	Rating **	M	Issue No.	23 (cont)
LM End	1.28	Issue Type +	En	Location *	LS

View of landward side.

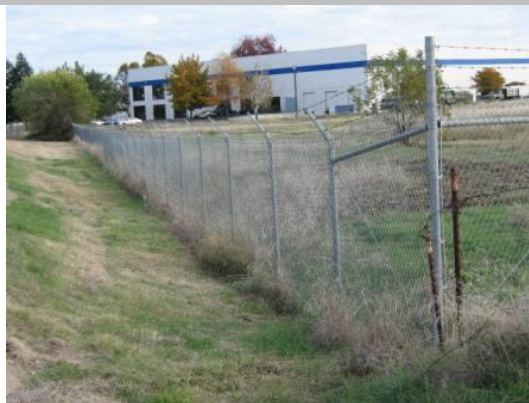
Photo 1 of 1 : SP_2017_NA0001_59_7_20170313_00005.jpg

LM Start	1.30	Rating **	M	Issue No.	7
LM End	1.33	Issue Type +	En	Location *	LS
Category	Earthen Levee			GPS Latitude/Longitude	
				Start	End
Item	Encroachments			38.661593 °	38.661370 °
				-121.431420 °	-121.430943 °
DWR ID	DWR_NA0001_08_s_2012_7				
Comment Code					
FE : Fence					
Inspector Comment					
Cyclone fence with barbed wire within 10' of toe for part of its alignment.

11/17/2011 Chainlink fence at levee toe.

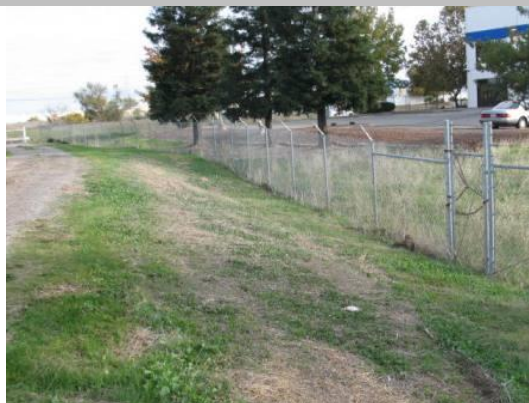
Photo 1 of 1 : SP_2017_NA0001_59_8_20170313_00006.jpg

LM Start	1.39	Rating **	M	Issue No.	8
LM End	1.43	Issue Type +	En	Location *	LS
Category	Earthen Levee			GPS Latitude/Longitude	
				Start	End
Item	Encroachments			38.660968 °	38.660828 °
				-121.430023 °	-121.429428 °
DWR ID	DWR_NA0001_08_s_2013_8				
Comment Code					
FE : Fence					
Inspector Comment					
Cyclone fence alignment returns to within 10' of toe.

11/17/2011 Chainlink fence alignment returns to the levee toe.

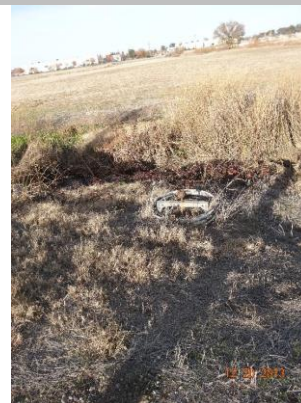
Photo 1 of 3 : UCIP_SP_2017_29329_54333.jpg

Comment Code					
Inspector Comment					
FS_ID:29329					
DS_ID:24384					
EP_NO: N/A					
Repair Type: Non-Urgent					
Crossing Status: Indicator Found					
UCIP Comments: Non-functional crossing--need to coordinate with owner, DWR-Inspector, and CVFPB to determine how to properly abandon crossing.					
FIELD_STRUCT_DESC: *ABANDONED* 24-inch pipe through the levee, 8.0 feet below the crown. Two CM cutoff walls around pipe. Slide gate in 30-inch CM riser and flap gate at waterside (WS) end. Concrete "U" headwall and splash apron on WS end. Landside (LS) end cutoff and plugged, riser filled with dirt. (USACE-1959). This entry matches the Drainage or Irrigation Structure referenced in O&M manual (Station 72+10).					
FS Date: 12/20/2013

View of riser with slide gate located on waterward side.

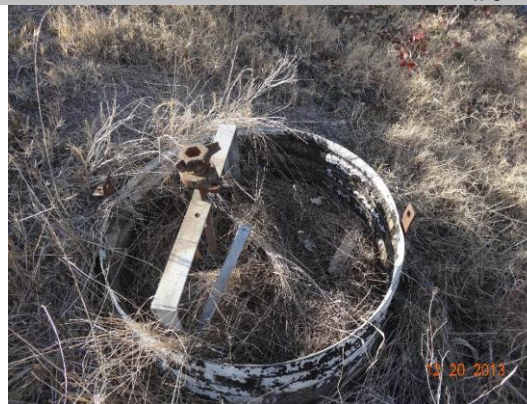
Photo 2 of 3 : UCIP_SP_2017_29329_54332.jpg

LM Start	1.40	Rating **	M	Issue No.	24 (cont)
LM End	1.40	Issue Type +	En	Location *	LS

Slide gate non-functional--riser filled with soil.

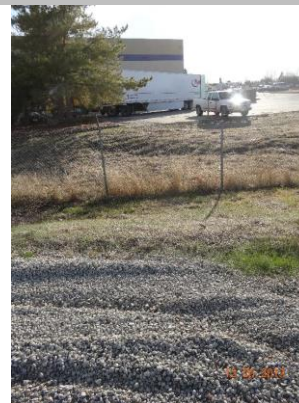
Photo 3 of 3 : UCIP_SP_2017_29329_54334.jpg

Comment Code						
Inspector Comment						
FS_ID:29329 DS_ID:24384 EP_NO: N/A Repair Type: Non-Urgent Crossing Status: Indicator Found UCIP Comments: Non-functional crossing--need to coordinate with owner, DWR-Inspector, and CVFPB to determine how to properly abandon crossing. FIELD_STRUCT_DESC: *ABANDONED* 24-inch pipe through the levee, 8.0 feet below the crown. Two CM cutoff walls around pipe. Slide gate in 30-inch CM riser and flap gate at waterside (WS) end. Concrete "U" headwall and splash apron on WS end. Landside (LS) end cutoff and plugged, riser filled with dirt. (USACE-1959). This entry matches the Drainage or Irrigation Structure referenced in O&M manual (Station 72+10). FS Date: 12/20/2013

View of landward side.

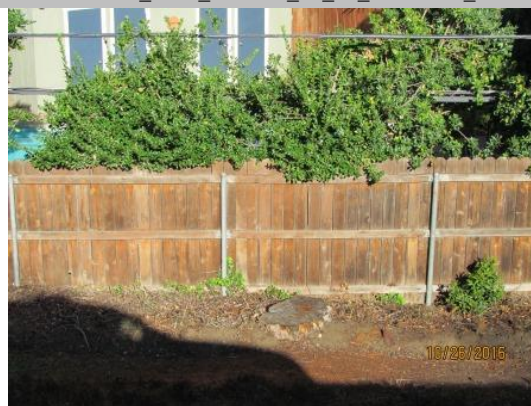
Photo 1 of 1 : SP_2017_NA0001_60_30_20170313_00010.jpg

LM Start	0.34	Rating **	N	Issue No.	30
LM End	0.34	Issue Type +	Ma	Location *	LS
Category	Earthen Levee			GPS Latitude/Longitude	
				Start	End
Item	Trim / Thin Trees			38.567267 °	38.567267 °
				-121.389069 °	-121.389069 °
DWR ID	DWR_NA0001_09_s_2016_30				
Comment Code					
T5 : Tree stumps.					
Inspector Comment

View of the tree stump on the landside levee toe.

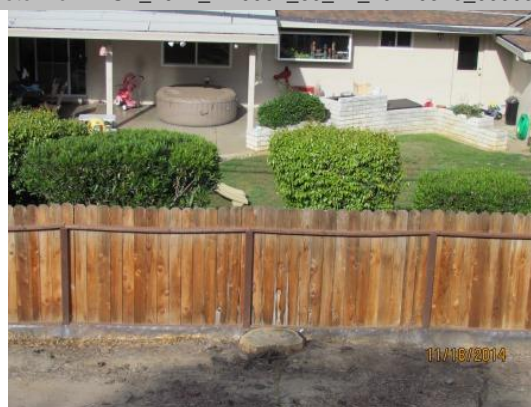
Photo 1 of 1 : SP_2017_NA0001_60_12_20170313_00003.jpg

LM Start	0.40	Rating **	N	Issue No.	12
LM End	0.40	Issue Type +	Ma	Location *	LS
Category	Earthen Levee			GPS Latitude/Longitude	
				Start	End
Item	Trim / Thin Trees			38.566725 °	38.566725 °
				-121.389935 °	-121.389935 °
DWR ID	DWR_NA0001_09_f_2013_12				
Comment Code					
T5 : Tree stumps.					
Inspector Comment

View of the tree stump at the landside levee toe.

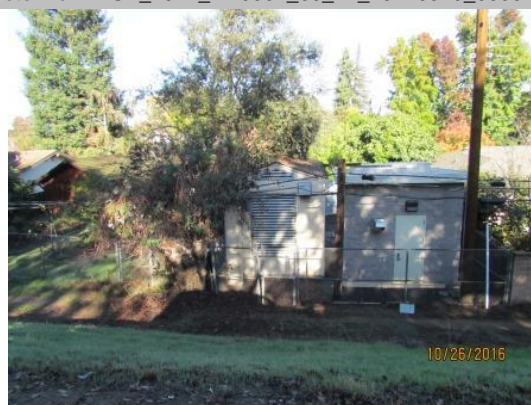
Photo 1 of 1 : SP_2017_NA0001_60_14_20170313_00004.jpg

LM Start	0.45	Rating **	N	Issue No.	14
LM End	0.45	Issue Type +	Ma	Location *	LS
Category	Earthen Levee			GPS Latitude/Longitude	
				Start	End
Item	Trim / Thin Trees			38.566298 °	38.566298 °
				-121.390680 °	-121.390680 °
DWR ID	DWR_NA0001_09_s_2012_14				
Comment Code					
T5 : Tree stumps.					
Inspector Comment					
Tree trunk at fence line.

Tree trunk at fence line.

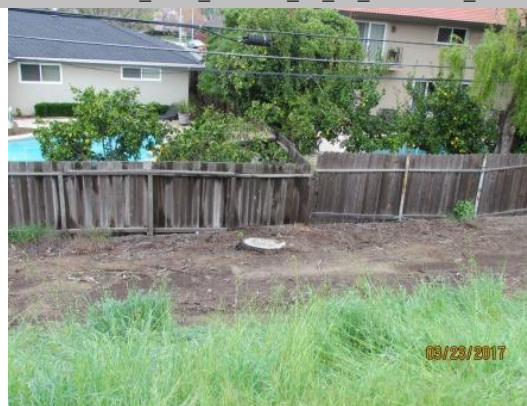
Photo 1 of 1 : SP_2017_NA0001_60_29_20170406_00046.jpg

LM Start	0.63	Rating **	N	Issue No.	29
LM End	0.63	Issue Type +	Ma	Location *	LS
Category	Earthen Levee			GPS Latitude/Longitude	
				Start	End
Item	Trim / Thin Trees			38.565255 °	38.565255 °
				-121.393595 °	-121.393595 °
DWR ID	DWR_NA0001_09_s_2017_29				
Comment Code					
T5 : Tree stumps.					
Inspector Comment

View of the tree stump within the levee easement.

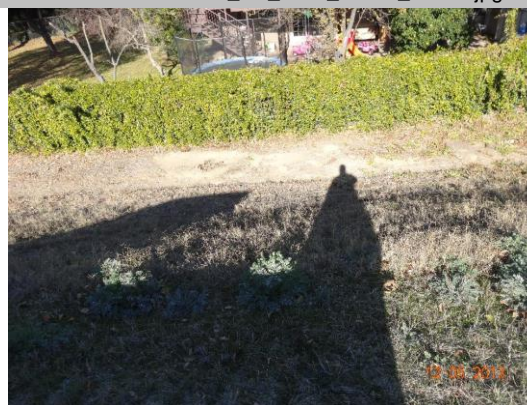
Photo 1 of 2 : UCIP_SP_2017_29347_54363.jpg

LM Start	1.29	Rating **	M	Issue No.	31
LM End	1.29	Issue Type +	En	Location *	LS
Category	Supplemental			GPS Latitude/Longitude	
				Start	End
Item	DWR UCIP Field Study			38.562285 °	38.562285 °
				-121.405265 °	-121.405265 °
DWR ID					
Comment Code					
Inspector Comment					
FS_ID:29347 DS_ID:24394 EP_NO: N/A Repair Type: Non-Urgent Crossing Status: Indicator Found UCIP Comments: Need to contact owner to determine status of crossing. FIELD_STRUCT_DESC: *ABANDONED* 12-inch steel pipe through the levee, 14.0 feet below the crown. Riser unit on waterside (WS). (USACE-1959). This entry matches the Drainage or Irrigation Structure referenced in O&M manual (Station 296+85). Pipe abandonment was referenced in Permit No. 4622 (1964). FS Date: 12/5/2013

View of landward side.

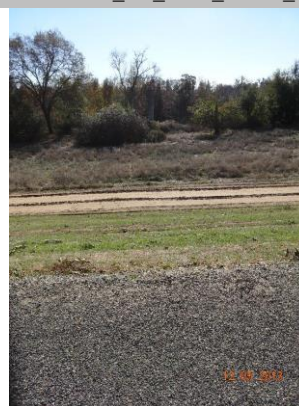
Photo 2 of 2 : UCIP_SP_2017_29347_54362.jpg

LM Start	1.29	Rating **	M	Issue No.	31 (cont)	
LM End	1.29	Issue Type +	En	Location *	LS	
Category	Supplemental			GPS Latitude/Longitude		
				Start		End
Item	DWR UCIP Field Study			38.562285 °		38.562285 °
				-121.405265 °		-121.405265 °
DWR ID						
Comment Code						
Inspector Comment						
FS_ID:29347 DS_ID:24394 EP_NO: N/A Repair Type: Non-Urgent Crossing Status: Indicator Found UCIP Comments: Need to contact owner to determine status of crossing. FIELD_STRUCT_DESC: *ABANDONED* 12-inch steel pipe through the levee, 14.0 feet below the crown. Riser unit on waterside (WS). (USACE-1959). This entry matches the Drainage or Irrigation Structure referenced in O&M manual (Station 296+85). Pipe abandonment was referenced in Permit No. 4622 (1964). FS Date: 12/5/2013

View of waterward side--tall riser located approximately 200 feet away.

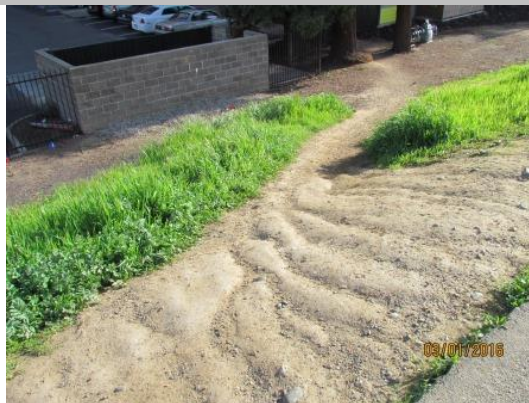
Photo 1 of 1 : SP_2017_NA0001_60_28_20170313_00009.jpg

View of the landside levee slope damaged by foot traffic.

LM Start	1.88	Rating **	A/W	Issue No.	28
LM End	1.88	Issue Type +	Ma	Location *	LS
Category	Earthen Levee			GPS Latitude/Longitude	
				Start	End
Item	Slope Stability			38.561171 °	38.561171 °
				-121.415808 °	-121.415808 °
DWR ID	DWR_NA0001_09_s_2016_28				
Comment Code					
S2 : Repair the levee slope damaged by foot traffic and prevent access where possible.					
Inspector Comment

View of the landside levee slope.

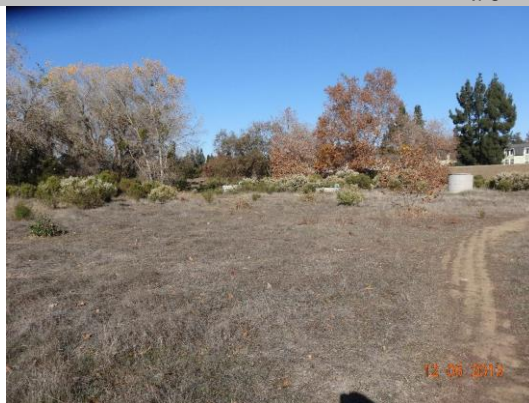
Photo 1 of 3 : UCIP_SP_2017_29351_54369.jpg

LM Start	1.93	Rating **	M	Issue No.	32
LM End	1.93	Issue Type +	En	Location *	LS
Category	Supplemental			GPS Latitude/Longitude	
				Start	End
Item	DWR UCIP Field Study			38.560889 °	38.560889 °
				-121.417196 °	-121.417196 °
DWR ID					
Comment Code					
Inspector Comment					
FS_ID:29351 DS_ID:24597 EP_NO: 17587 Repair Type: Non-Urgent Crossing Status: Indicator Found UCIP Comments: Unable to confirm if riser belongs to this crossing-- need to coordinate with owner to determine specifics. Description needs to be updated. FIELD_STRUCT_DESC: 54-inch water main through the levee at unknown depth. (Permit No. 17587-2003) FS Date: 12/5/2013

Three risers located on waterward berm.

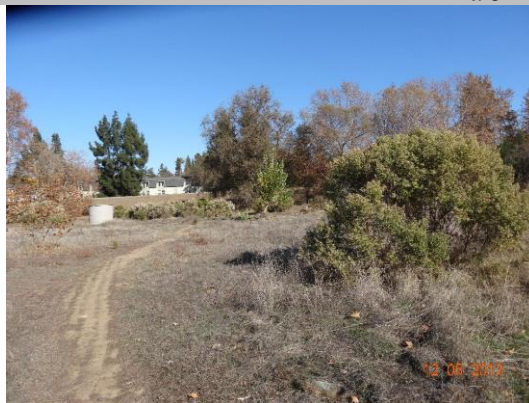
Photo 2 of 3 : UCIP_SP_2017_29351_54368.jpg

LM Start	1.93	Rating **	M	Issue No.	32 (cont)
LM End	1.93	Issue Type +	En	Location *	LS
Category	Supplemental			GPS Latitude/Longitude	
				Start	End
Item	DWR UCIP Field Study			38.560889 °	38.560889 °
				-121.417196 °	-121.417196 °
DWR ID					
Comment Code					
Inspector Comment					
FS_ID:29351					
DS_ID:24597					
EP_NO: 17587					
Repair Type: Non-Urgent					
Crossing Status: Indicator Found					
UCIP Comments: Unable to confirm if riser belongs to this crossing--need to coordinate with owner to determine specifics. Description needs to be updated.					
FIELD_STRUCT_DESC: 54-inch water main through the levee at unknown depth. (Permit No. 17587-2003)					
FS Date: 12/5/2013

View of waterward berm looking toward levee crown from waterward berm edge.

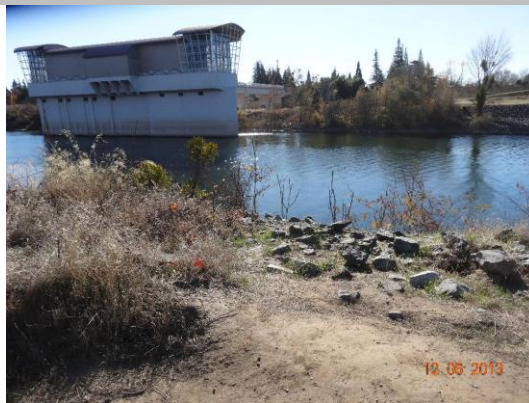
Photo 3 of 3 : UCIP_SP_2017_29351_54367.jpg

View of waterward edge--rip rap armor along toe.
